UNDERWATER BRIDGE INSPECTION REPORT

STRUCTURE NO. 84524
CSAH NO. 32
OVER THE
BUFFALO RIVER
DISTRICT 4 - WILKIN COUNTY

PREPARED FOR THE
MINNESOTA DEPARTMENT OF TRANSPORTATION
BY
COLLINS ENGINEERS, INC.
JOB NO. 5221

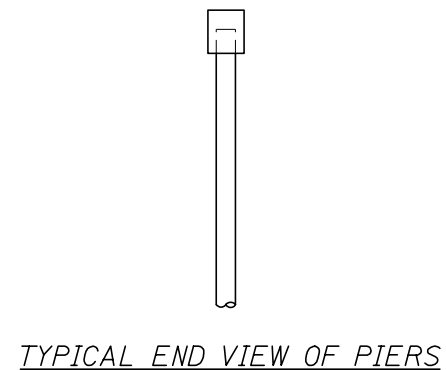
INSPECTION AND SOUNDING PLAN

- The channel bottom around both piers consisted of soft silt, sand, and random stones with up to 18 inch diameter with up to 2 feet of probe rod penetration.
- Piers 1 and 2 exhibited coating loss from channel bottom to 3 feet above the channel bottom. The exposed steel exhibited minor surface corrosion with no appreciable loss of section.
- A 10 feet long (N/S) by 5 feet wide (E/W) by 1 foot deep scour depression was observed around the two upstream piles of Pier 2.
